ACCUSTEAM
HIGH PRODUCTION GRIDDLE

TECHNICAL BULLETIN

BULLETIN #: SP8176-2512	NOTICE: THIS DOCUMENT CONTAINS INFORMATION PROPRIETARY TO ACCUTEMP PRODUCTS, INC. AND IS TO BE USED ONLY BY AUTHORIZED SERVICE PERSONNEL. DUPLICATION OR REPRODUCTION OF THIS DOCUMENT IN ANY OTHER FORM, IN WHOLE OR IN PART, IS STRICTLY PROHIBITED
DATE: 12/30/2025	
SUBJECT: ACCUSTEAM G2 GRIDDLE - INFRARED INSTALLATION INSTRUCTIONS - 36" MODEL.	
MODELS: GGX1201X3650 & PGX1201X3650	
SERIAL NUMBER: 16514 and up

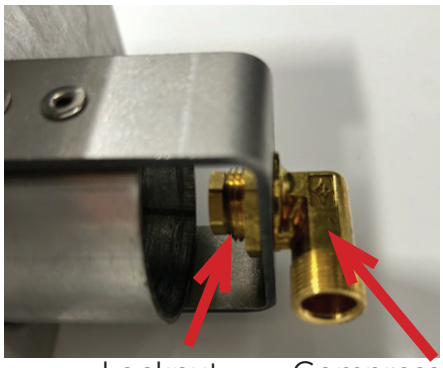
Fig 5

Locknut Compression Elbow

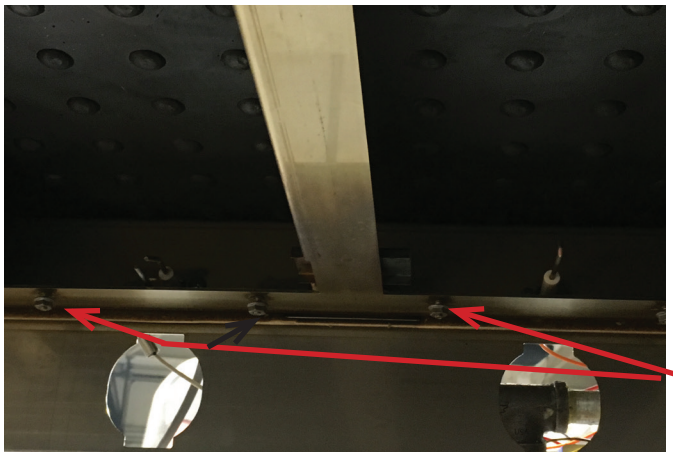
Fig 6

Loosened front burner fasteners

⚠ When tightening the four fasteners on the burner, ensure they are all evenly tight and secure. Loose front fasteners will cause a backfire when the unit heats.

Return to rear fasteners and secure.

8. Hand tighten rear fasteners back into place. Then use a socket wrench to snug front fasteners. Return to rear fasteners and secure.
